## Mid-Year Cool

Second-generation Corvettes have a reputation for inferior air-conditioning systems. But properly restored and treated to a few key upgrades, they can be made to work well.

BY HAROLD PACE PHOTOS BY CARR CAMPBELL

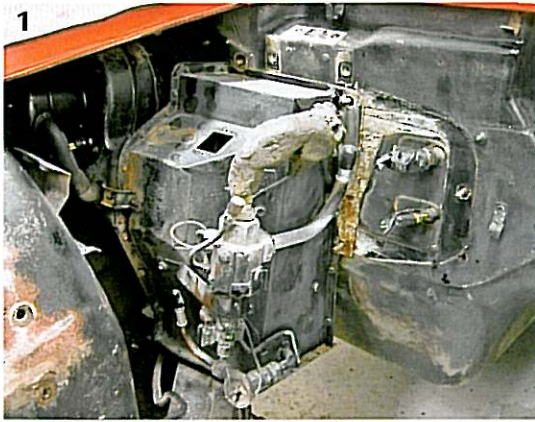
1: The original a/c system was basically intact, but had been open to the atmosphere and rodents for many years.

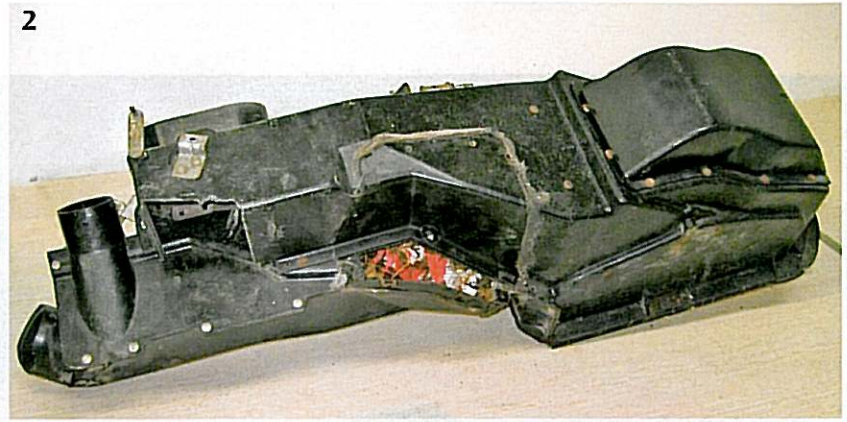
2: The first step in the process is to remove the inner heater box. The factory assembly manual is a good guide for this. You can see in the photo that the entire inside of the box had been made into a rats' nest. This is a common occurrence.

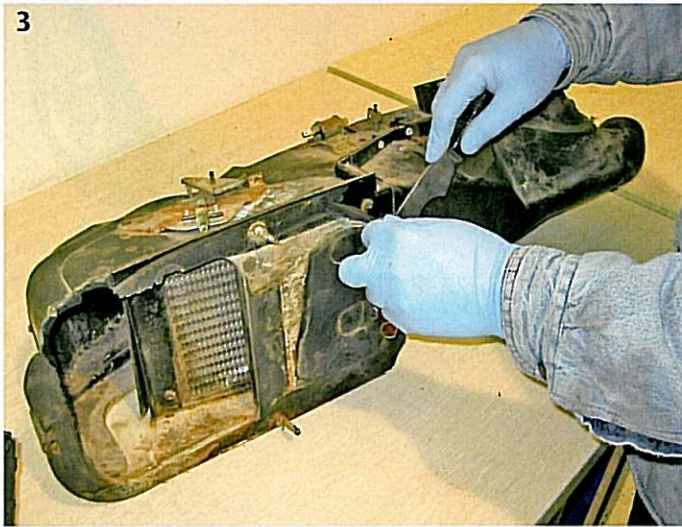
3: Disassembly of the heater box begins with removal of the rear cover plate.

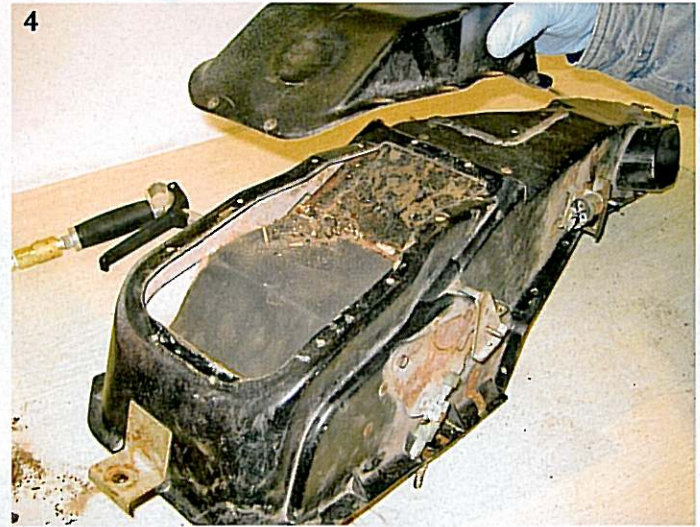
4: Then the front primary cover plate can be removed. There is usually a lot of debris here.

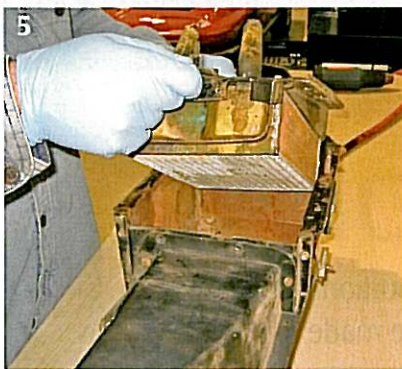
5: After the cover plates are removed you can pull out the heater core.

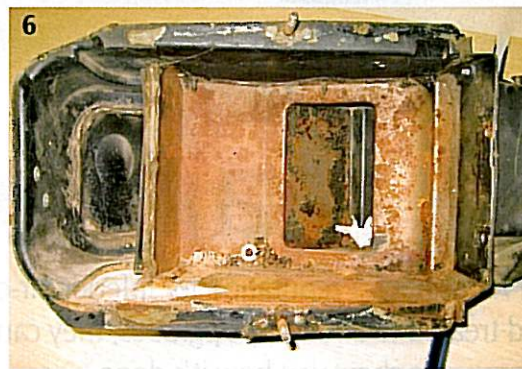
6: There is typically a lot of debris behind the heater core; it's amazing what you find.

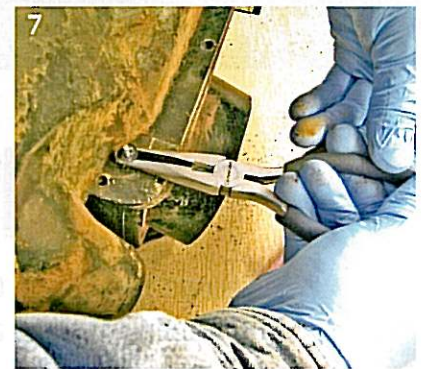
7: You can now begin to split the case. Look for the push nut on top of the blend door; remove and save it, if possible.

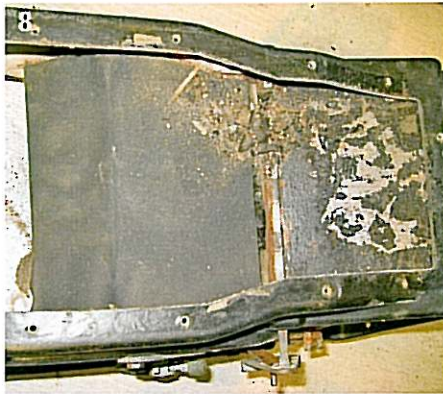
8: You can see the shaft of the blend door through the case.

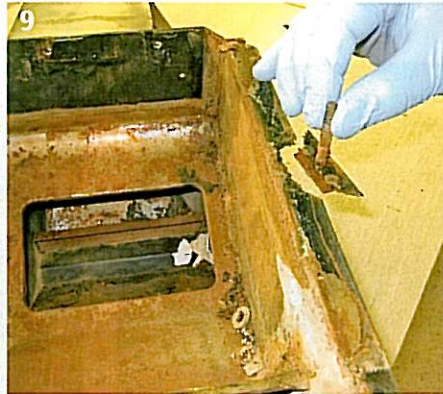
9: A lot of the cases we see have some type of damage on the firewall mounting flanges from being over-tightened at the factory, or previous repair work. These will be reattached with a fiberglass bonding compound, sanded and repaired so the damage will not be detectable.

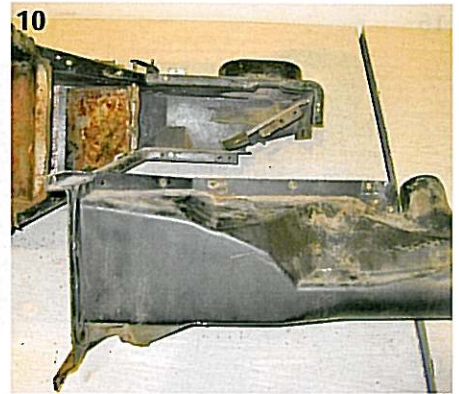
10: Here you can see the case has been split.

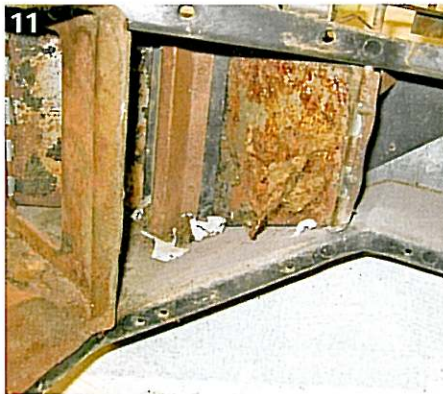
11: There is typically a lot of corrosion of the metal components inside the heater box.

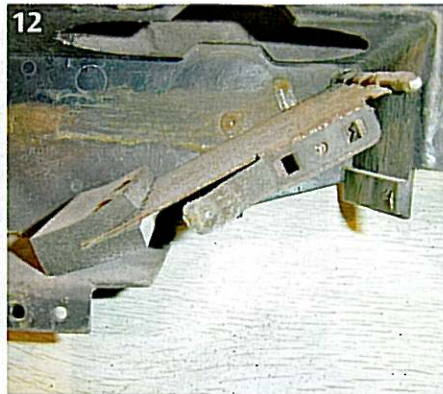
12: The blend door and shaft can now be separated and removed from the case.

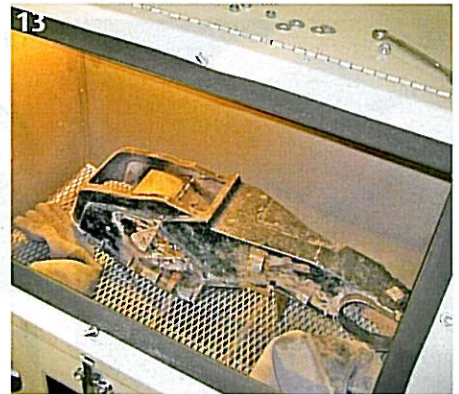
13: Clean the disassembled components to remove corrosion, dirt and grime.

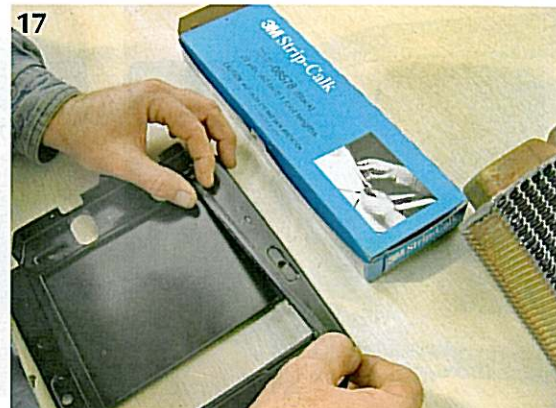
17: Begin reassembly by very thoroughly applying strip caulk to every mating surface.

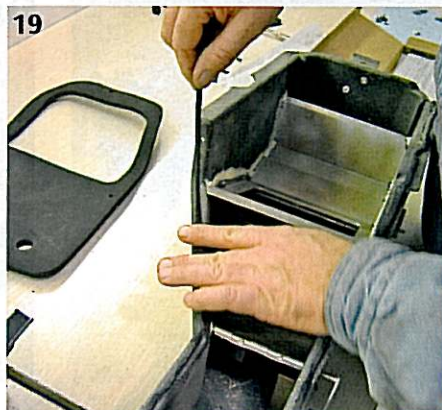
19: Prep the heater box mating surfaces, and install a new seal kit.

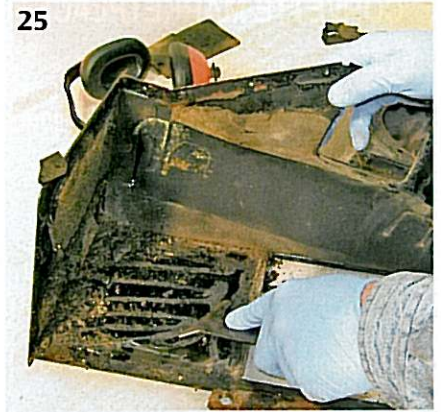
25: Remove all of the original insulating material, which isn't much, from the inside of the evaporator case.

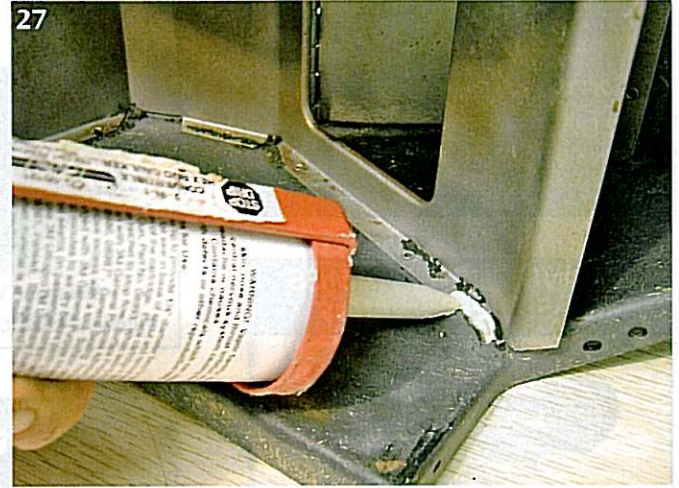
27: Apply seam sealer to all the flanges inside the assembly to improve efficiency.

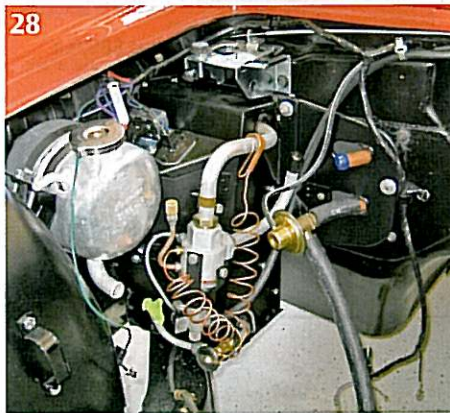
28: The reassembled evaporator core assembly installed on the firewall with the original hardware and tubes. You can also see the new expansion valve.

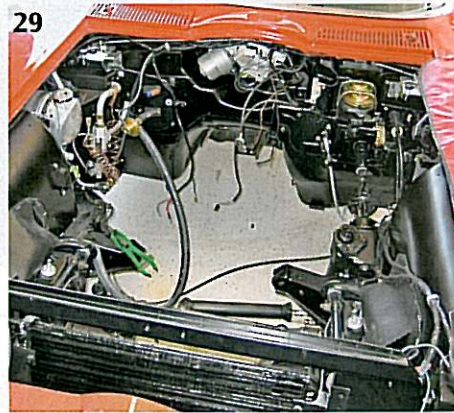
29: The entire engine compartment was restored as part of the project, which explains the missing motor.
